Properties of printing materials

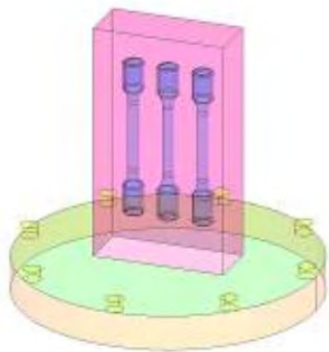
Horizontal

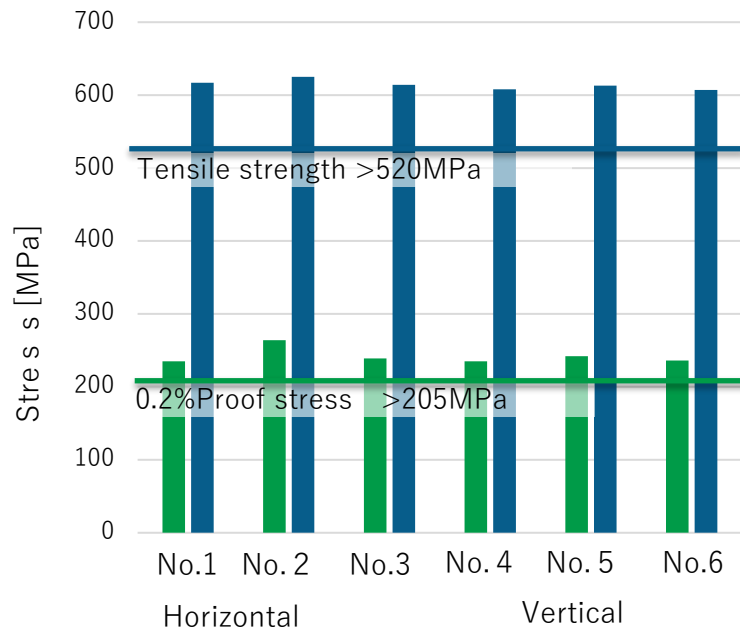
Vertical

Tensile strength test result

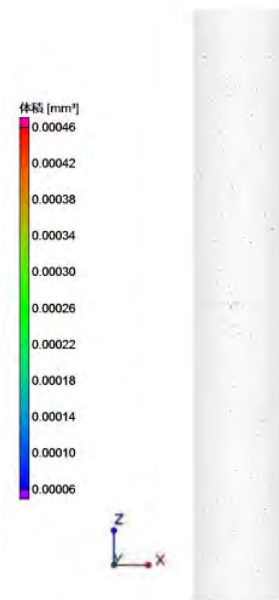
X-ray CT inspection results

defect volume fraction
< 0.01%

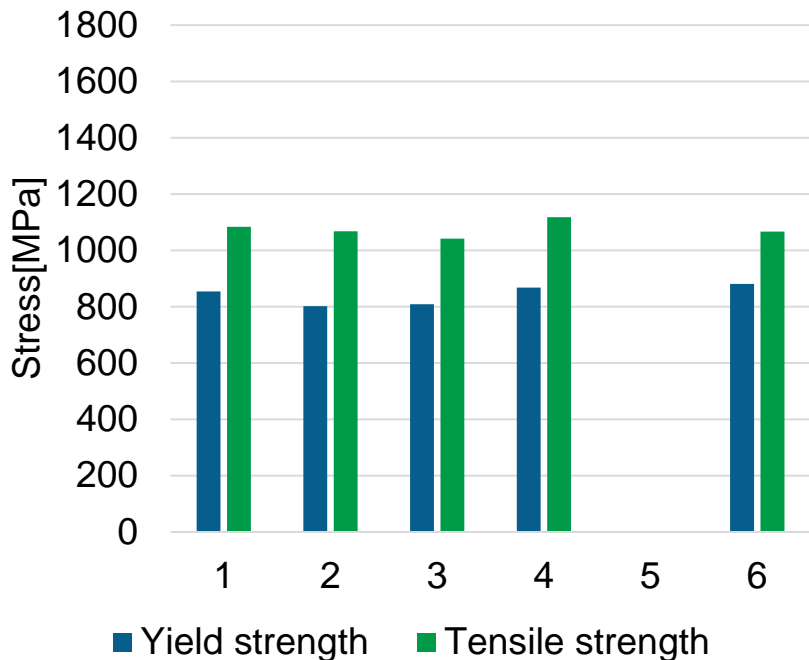
As Built

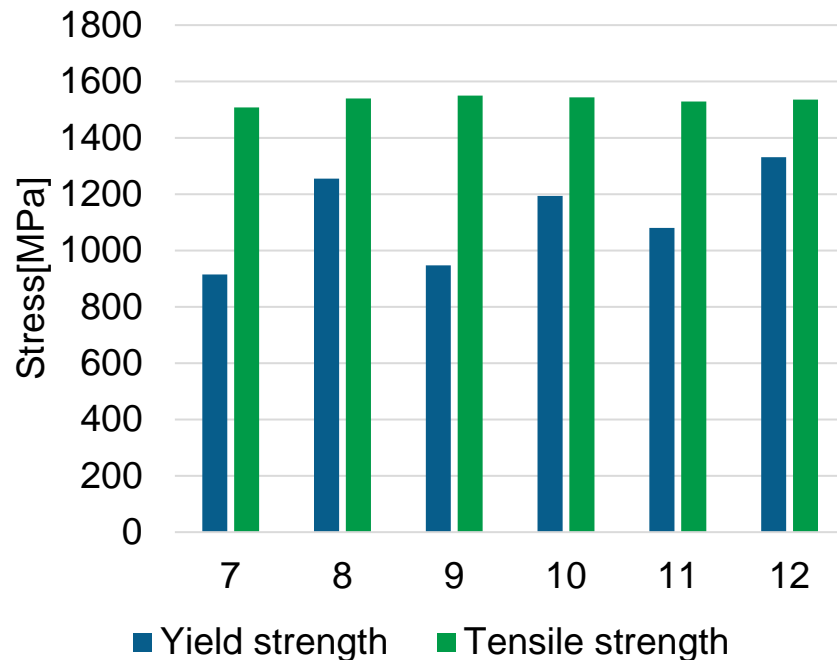
Solution treatment and aging
